DEPARTMENT OF TRANSPORTATION**DIVISION OF ENGINEERING SERVICES**

Contract #: 04-0120F4Cty: SF/ALA Rte: 80 PM: 13.2/13.9File #: 69.28**WELDING INSPECTION REPORT****Resident Engineer:** Pursell, Gary**Address:** 333 Burma Road**City:** Oakland, CA 94607**Report No:** WIR-003346**Date Inspected:** 18-Jul-2008**Project Name:** SAS Superstructure**OSM Arrival Time:** 1400**Prime Contractor:** American Bridge/Fluor Enterprises, a JV**OSM Departure Time:** 2230**Contractor:** Zhenhua Port Machinery Company, Ltd (ZPMC), Changxing Island **Location:** Shanghai China

Caltrans Quality Assurance (QA) Inspector, Larry Viars was present observe production welding and perform Ultrasonic Testing (UT) of Orthotropic Box Girder (OBG) and Tower components, for the San Francisco Oakland Bay Self Anchored Suspension Bridge, at Zhenhua Port Machinery Company (ZPMC) facility on Changxing Island.

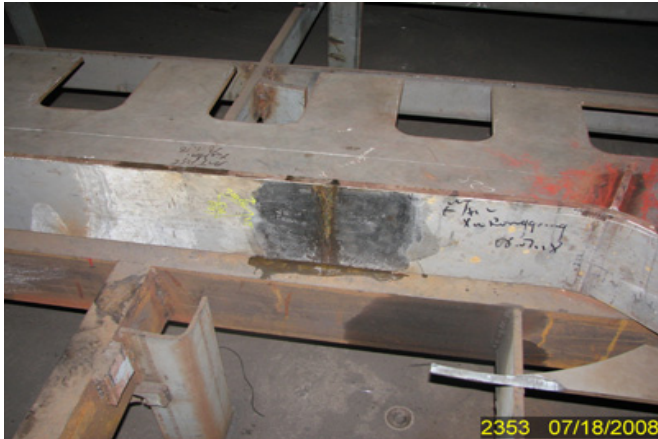
The Caltrans QA Inspector performed Ultrasonic verification of Floor Beam repair welds FB034-001-122 (R1) and FB011-006-043 (R1). Ultrasonic testing was performed with a 70 degree transducer. Repair areas appeared to meet the requirements of AWS D1.5 (2002) table 6.3. Please see the UT report TL-6027 generated on this date for the above mentioned UT testing on this date. Please see the attached photo of FB011-006-043 shown below
